石窟寺岩体劣化机制与失稳机理研究进展

Advances in Degradation and Instability Mechanism of Grotto Temple Rock Mass

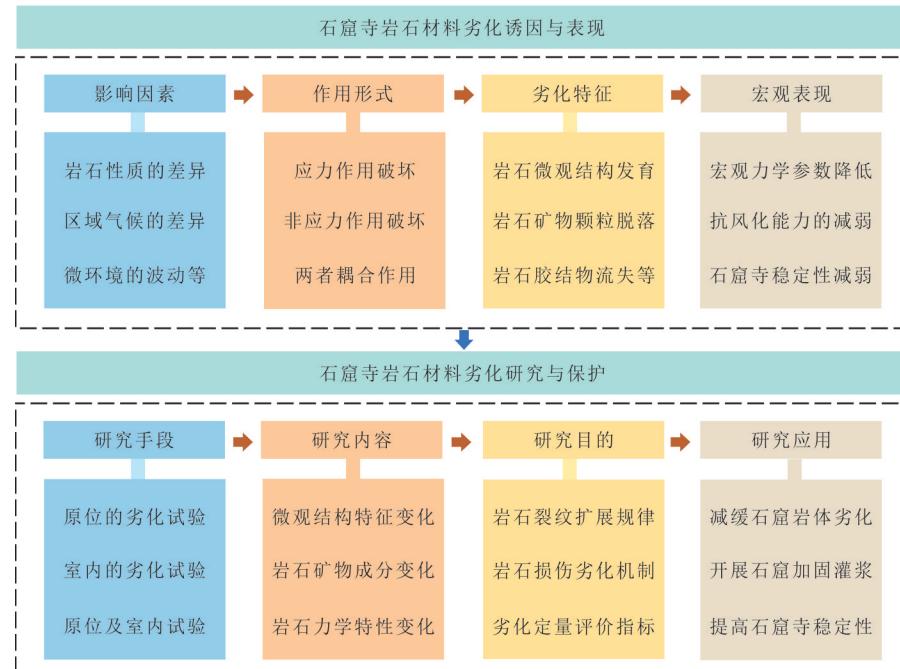
图1 石窟寺岩石材料的劣化
Fig.1 Deterioration of rock materials in grotto temple

综上所述,石窟寺岩体是一种具有初始损伤的介质,微结构的损伤演化多沿着较为薄弱的区域发生.在不同影响因素作用下,岩石的裂纹扩展特征、破坏形式均存在较大的差异性,针对石窟岩石材料的劣化研究与保护需采取多种研究手段,探明岩石的损伤演化机制、裂纹起裂扩展规律等,以求减缓岩石材料的劣化,提高石窟寺稳定性(图1).值得注意的是,由于石窟文物的特殊性,石窟寺保护区的原位损伤劣化试验难以开展,而通过室内试验的手段重现岩石材料的损伤演化过程则存在一定的局限性.因此,可以考虑在石窟研究区附近选取赋存环境较为一致的人工洞窟开展原位试验研究,同时结合室内试验数据更加准确地分析石窟寺岩体的损伤劣化机制.相关研究成果不局限于定性分析,在定量或半定量评价方面也应有新的进展.

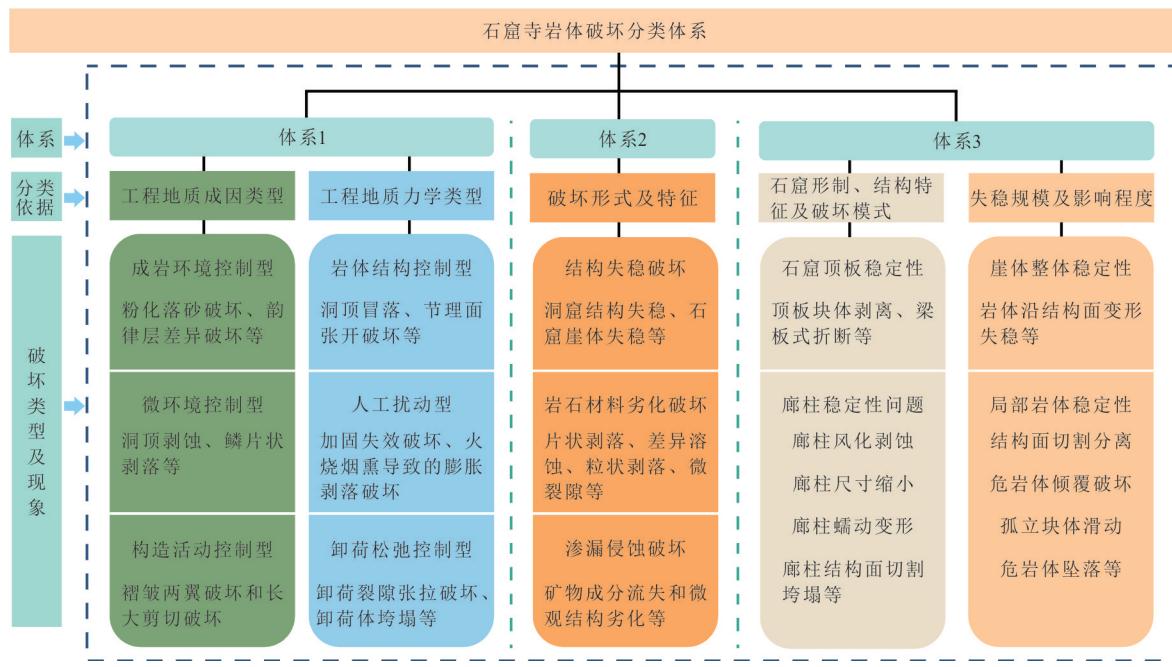
图 2 石窟寺岩体破坏分类

综合前人的研究成果来看,石窟寺岩体破坏类型的划分尚不成熟与完善,划分依据存在较大差异,如:李宏松(2011)从石质文物病害的破坏形式及特征出发,提出了结构失稳、渗漏侵蚀、岩石材料劣化3种破坏类型;王金华等(2013)从规模、影响程度以及石窟形制几个方面对石窟寺岩体的失稳破坏模式进行划分;刘世杰等(2022)从工程地质的角度将石窟的变形破坏类型分为工程地质成因型和工程地质力学型,建立了2大类、6亚类、24种破坏现象的综合分类体系,以上3种分类如图2所示。除此之外,笔者认为从破坏现象、破坏形态、破坏诱因及损毁程度等几个方面划分也具有一定的合理性。目前,学者们多以研究石窟寺洞窟的稳定性与破坏形式为主,尚未形成权威、统一的石窟寺失稳破坏分类体系。而关于石窟寺的结构失稳,学者们研究较多的为不同尺度的危岩体,同时也意识到了复杂结构面在岩体失稳中所扮演的重要角色。尤其是失稳现象普遍存在且具有特殊塌落机理和破坏规律的石窟顶板,针对其失稳机理与加固技术的研究已成为当前众多学者关注的热点。

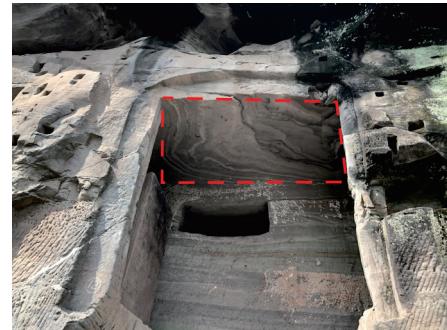
3.2.2 层理 在水动力强弱交替下形成的弱面型层理粘结较弱,易发生沿层理面的剪切滑移与垂直层理的张性破坏(孟召平等,2009).当层理较为发育时,在内外因素的综合作用下,洞窟顶部岩体因抗拉强度不足而沿层理面产生裂缝,致使洞顶下部岩体与上方岩体产生离层,发生逐步坍落破坏,破坏形式多为沿水平层面的逐层剥落坍塌(齐干等,2011),如四川安岳圆觉洞12号窟顶板表现出的片状剥落现象(图3).一般而言,弱面型层理面的粗糙程度和发育密集度会显著影响石窟寺岩体的整体稳定性.层理越发育,顶板岩层在内外营力作用下稳定性越低,且水平层理及平整光滑层理比斜交波状层理及粗糙不平整层理比更易产生离层(钱四发,2003).与构造、卸荷裂隙对石窟寺影响不同的是,弱面型层理是岩体中的原生结构,风化可以沿层理面发生,使洞窟壁面上形成条状凹槽.此外,弱面型层理面的存在也可使得水溶液较顺畅地进入岩体内部,加速岩体中碳酸盐胶结物的风化(马在平等,2005).

图3 安岳圆觉洞12号窟顶板沿层理面发生剥落

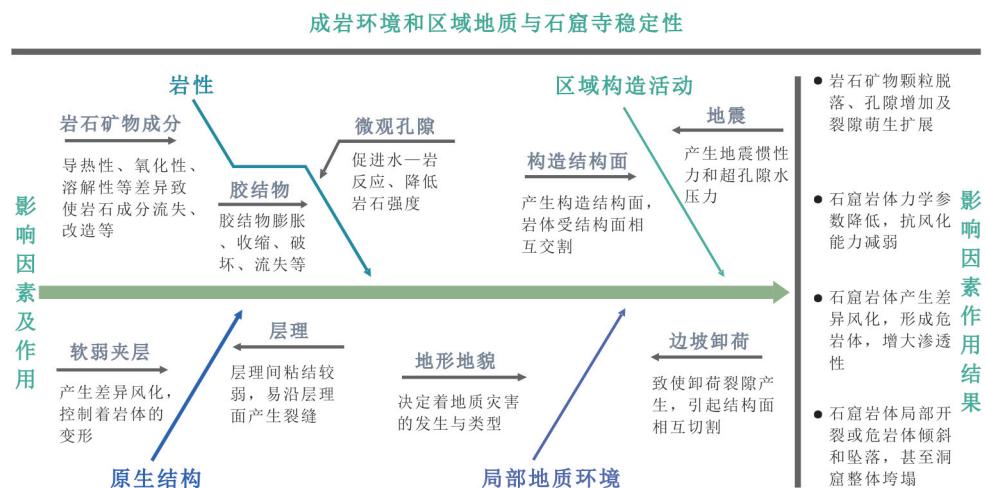
图4 成岩环境与区域稳定性对石窟寺稳定性的影响

石窟寺独特的成岩环境和地质环境决定了岩体病害的类型和发展趋势,这种自然营力作用导致的劣化失稳属于极难抗拒的作用因素,其影响机理复杂(图4)。分析研究区域内地层岩性、岩体结构、局部地质环境、地震活动是石窟寺岩体稳定性研究的基础,其中岩体结构与另外三者的关系密不可分,不仅对岩体稳定性有着重要的影响,而且促进水分在岩体内部的运移,加剧水岩反应。目前,关于

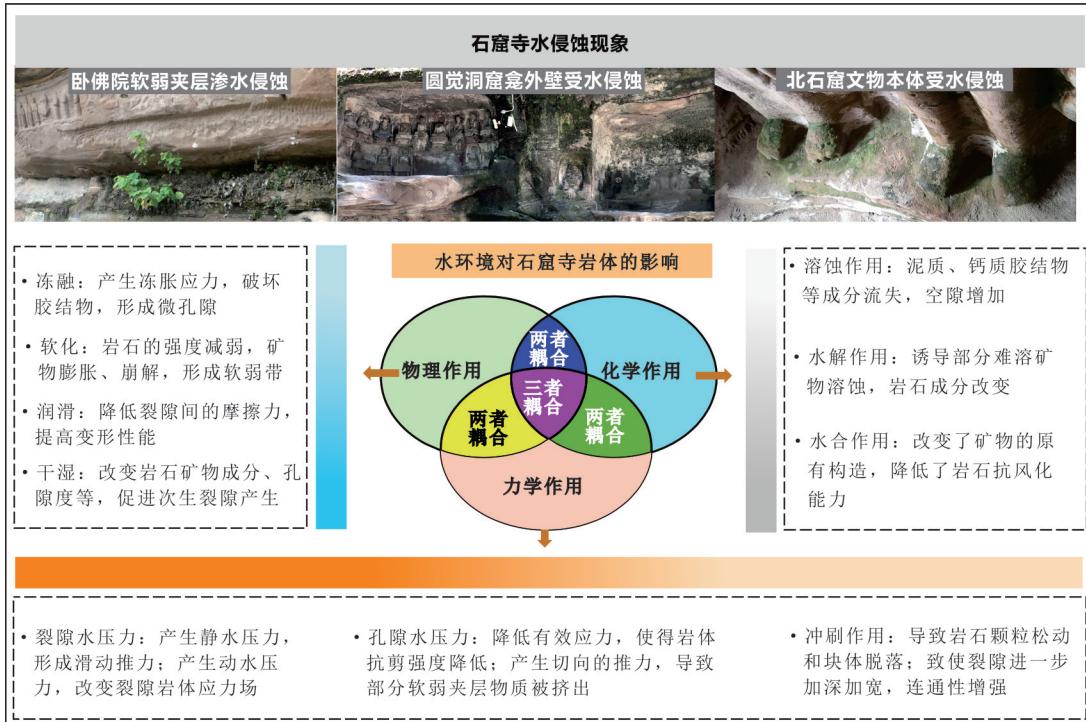
图6 水岩作用下石窟寺岩体的劣化破坏机理

水环境对石窟寺岩体的劣化失稳影响较大,作用机理复杂,以物理、力学和化学作用为主导(图6)。根据上述讨论内容,可将其作用机理简单总结为石窟岩石矿物成分的改变、胶结物的流失、矿物颗粒物理力学性质的变化、水分子产生的冻胀应力、水压力以及冲刷作用。现有的研究一部分是以现场调查为基础的定性分析,另一部分则是针对石窟寺水害开展的劣化模拟试验,主要以干湿循环和冻融循环为主,涉及范围较窄。

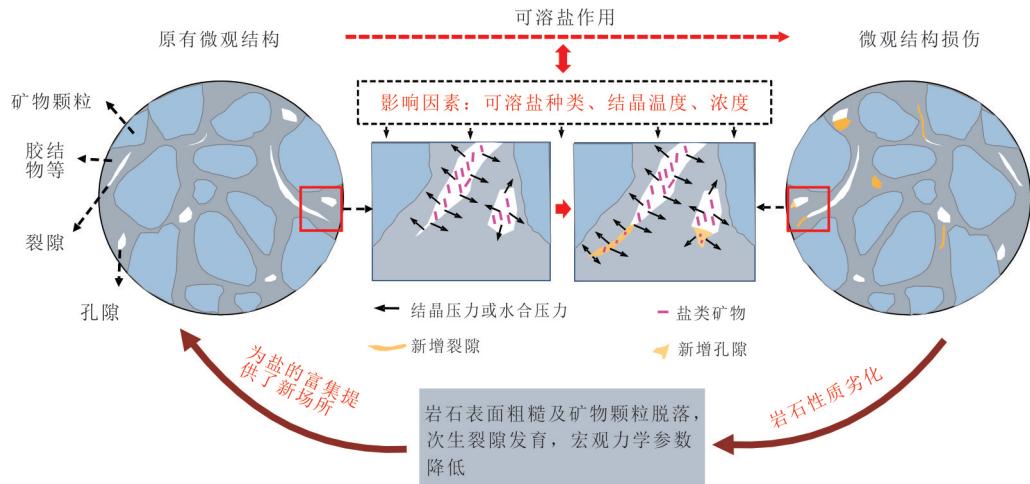
图 7 可溶盐对岩石微观结构破坏示意图

关于可溶盐对石窟寺岩体的劣化机理,学者们开展了丰富的室内劣化模拟试验,研究类型以Na₂SO₄和NaCl为主,集中在可溶盐的风化速度、风化产物、风化机理、岩石的物理力学特性等方面。研究结果普遍认为硫酸盐具有较强的风化能力,其结晶和水化是极易引起石窟寺岩体的风化破坏。同时,盐风化是一种包含有物理风化和化学风化的特殊风化类型,以化学过程为机制,以物理过程为结果,主要由矿物结晶膨胀和矿物水合膨胀两种机制共同作用(图7)。且结晶压力与水合压力密不可分,时常伴生出现(靳治良等,2017)。目前,关于盐风化的微观机理仍需要进一步研究,如盐结晶在岩石不同尺寸孔隙中的生长顺序、盐结晶的运移等。

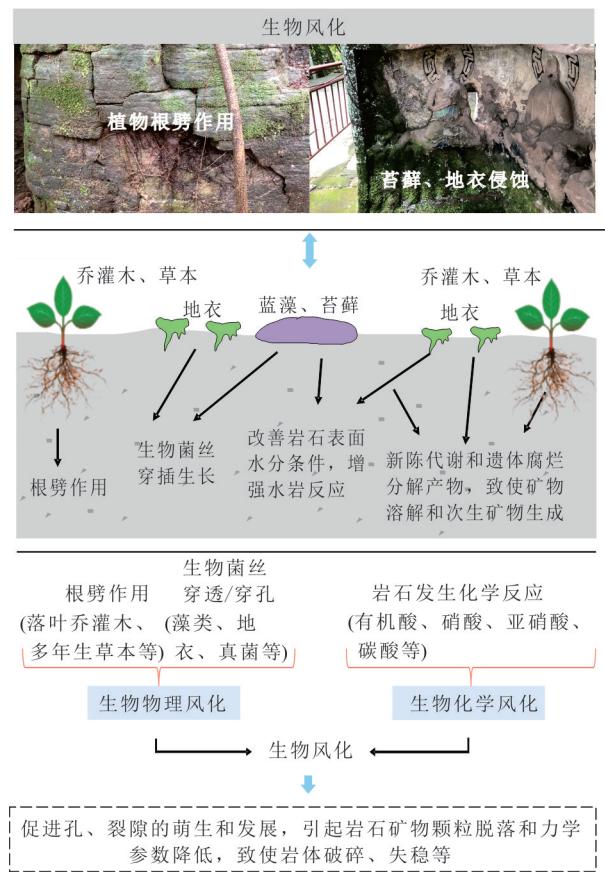
图8 生物活动对岩体的影响机制

我国石质文物资源十分丰富,因长期在自然界中暴露,易受到生物因素的侵害(Prieto and Silva, 2005)。近年来,石质文物的生物风化病害越来越严重,受到专家学者们的重要关注。生物风化是指岩石矿物受生物生长及活动影响而发生的风化作用,生物生命的整个过程都能对它周围的岩石产生破坏(宋金凤等,2019)。根据生物破坏的作用机理,石质文物的生物风化作用可分为生物化学风化和生物物理风化(图8)。

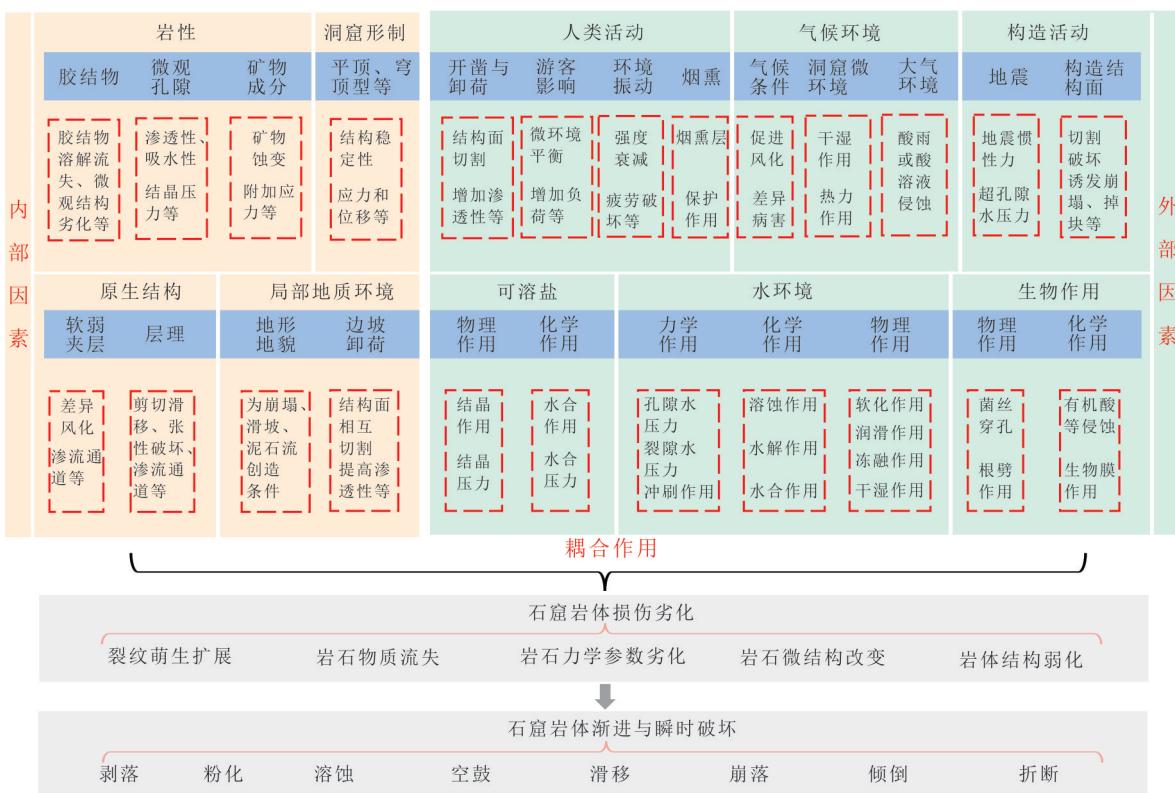
Fig.9 Schematic diagram of degradation and failure mechanism of rock mass in grotto temple

单一因素的分析虽易于厘清某一因素对石窟寺岩体的劣化机理,但石窟文物的失稳破坏往往是多因素耦合作用引起的(图9)。割裂各因素之间的耦合关系无法准确地解释和模拟石窟寺岩体病害的发生和发展过程,甚至在机理研究过程中会出现前后矛盾的现象(王旭东等,2015)。因此,学者们也开展了不同因素组合下的劣化试验,以期更好地厘清失稳机理。目前,研究多以两个因素耦合产生的影响为主,如温度与可溶盐(严绍军等,2015)、CO₂与水(张傲等,2012)、温度和酸(严绍军等,2018)等对石窟寺岩体的破坏。丁梧秀等(2015)表明水化学溶液和冻融耦合侵蚀作用对龙门石窟灰岩的强度损伤较大,岩石的细观结构损伤及力学性能劣化显著,溶液中凝结核的丰度和溶液的pH值是影响灰岩损伤程度的重要因素;方云等(2015)研究了CO₂龙门石窟碳酸盐岩体的劣化机理,发现CO₂气体加剧凝结水对龙门石窟赋存岩体的劣化过程,劣化作用受晶体习性与解理面结构控制,定量评价了CO₂的侵蚀效果;刘海康等(2017)研究了不同含水率状态下砂岩的冻融试验,通过对比试验前后云冈石窟砂岩吸水率、纵波波速、单轴抗压强度等参数,发现砂岩饱和度小于30%时参数基本不受冻融作用影响,确定了云冈石窟砂岩冻融损伤的“阈值”。此外,开展多场耦合条件下的环境模拟技术研究也具有重大意义。王旭东等(2015)首次研发了基于多场耦合下的石窟围岩风化机理模拟试验系统装置,为石窟围岩劣化机理的研究提供了高技术环境仿真试验平台。
